Geomembrane and GCL mining usage tests

Remote mountainous sites in Chile and Colorado supply test pad locations to evaluate geomembrane and GCL field performance for mining applications.

By Phillip Crouse, Brian Jacobs, Patrick Corser and John Redmond

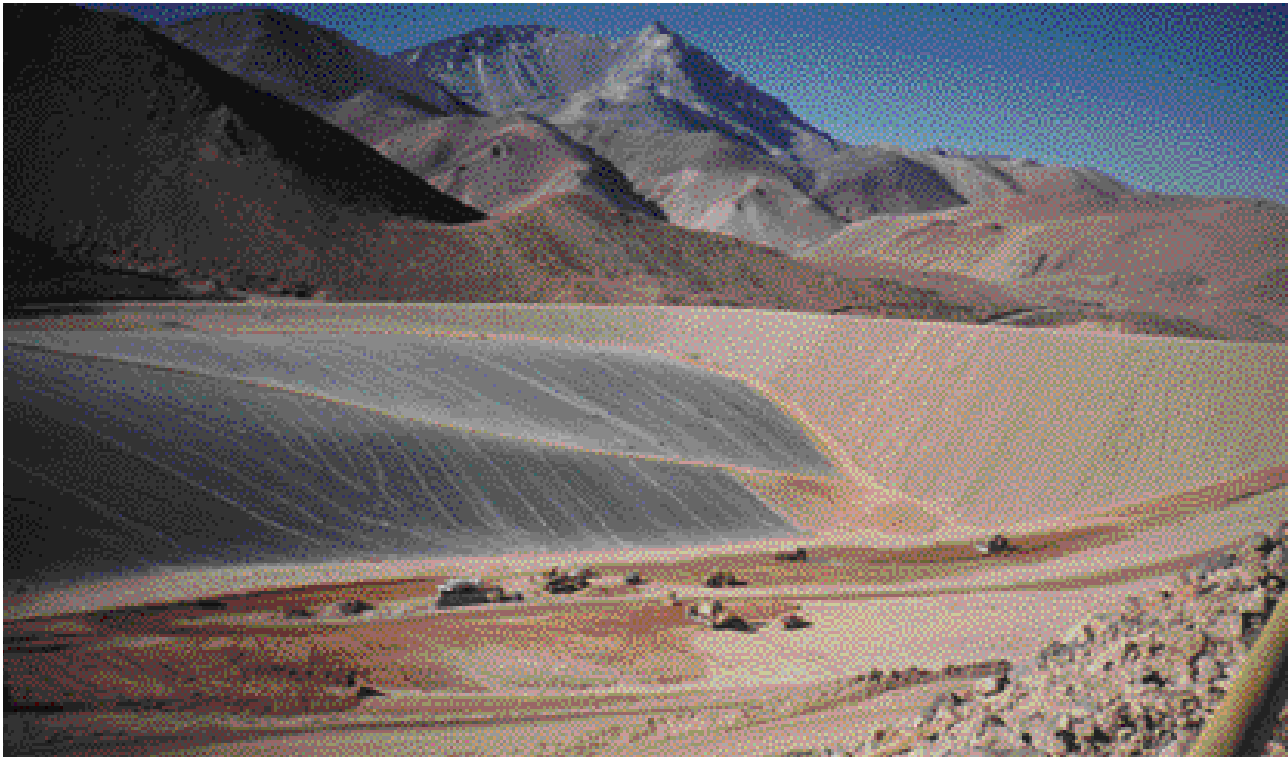
Lining an impoundment and dam at a gold mine located over 14,000 feet in elevation in the Andes Mountains of Chile, South America. High sloping canyon walls formed the sides of the impoundment, with a rock-filled dam located downstream. The dam is 200 ft high and is constructed from mine overburden rock. A dual geomembrane liner and geonet leak-collection system provided a seal to inhibit seepage through the porous rock fill.

Approximately 6.0 million sq. ft of high-density polyethylene (HDPE) geomembrane was used to line two tailing impoundments at an active gold mine located in the Andes mountains. High sloping canyon walls formed the sides of the impoundment, and two rock-fill dams framed the upper and lower portions of the canyon. The upper and lower dams are approximately 200 ft high and were constructed from mine overburden rock, with upstream slopes of 3H:1V and 2H:1V, respectively. A dual geomembrane liner and geonet leak-collection system provided a seal to inhibit seepage through the porous rock-fill.

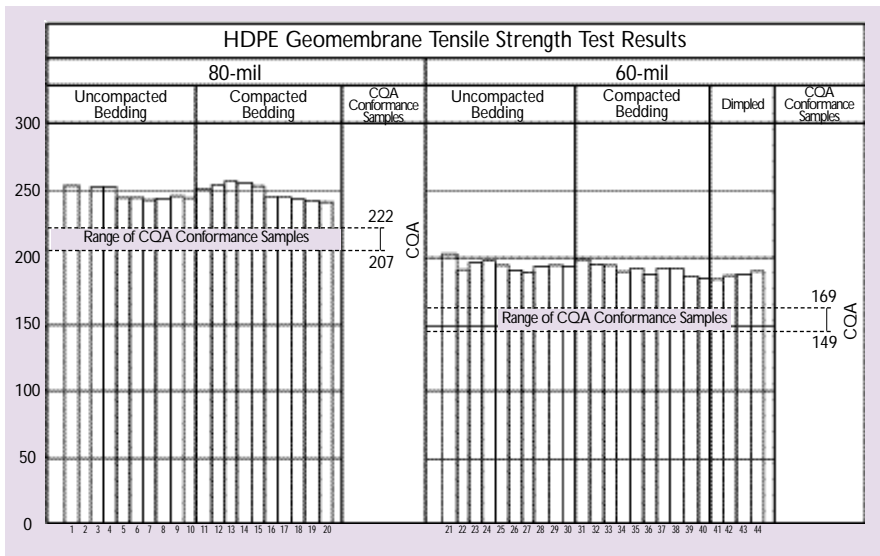
Figure 2: Results of tensile strength tests.

The tensile-strength test results of the 44 specimens cut from the exhumed samples are graphically illustrated in **Figure 2**. The CQA conformance test results are also shown on the figure for comparison purposes. The tensile strength of the exhumed geomembrane samples were within approx-

imately 20 percent of the conformance test results, indicating that the tensile behavior of the geomembrane was not adversely impacted by the coarse sand bedding material. Additionally, the tensile strength trend of the exhumed material was higher than the conformance test results. Most likely, this was due to the different aspect ratios of the test specimens. The larger aspect ratio of the specimens tested in the field may have minimized the Poisson effect (i.e., contraction within the central region) giving it a stronger load extension response as compared to the smaller aspect ratio of the specimens tested in the laboratory using ASTM D-638 (Koerner, 1994).

The tensile strengths of the dimpled samples were slightly less than the other samples, but still above the CQA conformance range. Dimples or indents are local deformations that can develop concentrated stress and strain in a geomembrane and should be avoided for landfill lining systems (Heerten et al., 1991). Although small dimples occurred in the secondary geomembrane, the adverse effects were anticipated to be small for the following reasons:

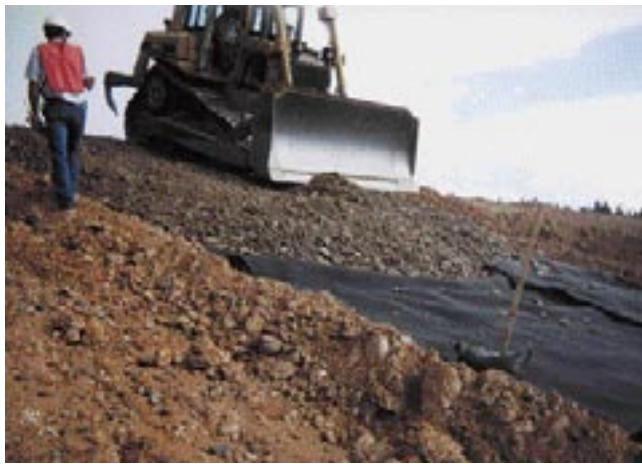
Photo 3: Spreading rock cover over geosynthetics

a dry state. The geocomposite was then installed over the GCL followed by an 18-in.-thick lift of the proposed soil/rock cover material spread by the bulldozer and track-walked as illustrated in **Photo 3**.

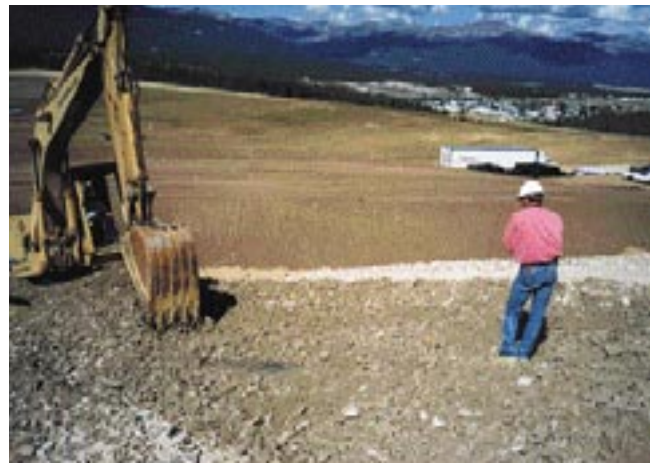
Photo 4: Removing rock cover

After examination, the rock cover was removed (**Photo 4**), exposing the underlying geosynthetics. The teeth on the bucket of the backhoe removing the rock cover caused some damage to the underlying geo-

composite. It is recommended that a “screed” be attached to the teeth of the bucket. This has worked well in other published field studies (Richardson and Johnson, 1998). After the initial damage caused by the backhoe bucket, the remaining rock cover was removed primarily by hand to prevent further damage.

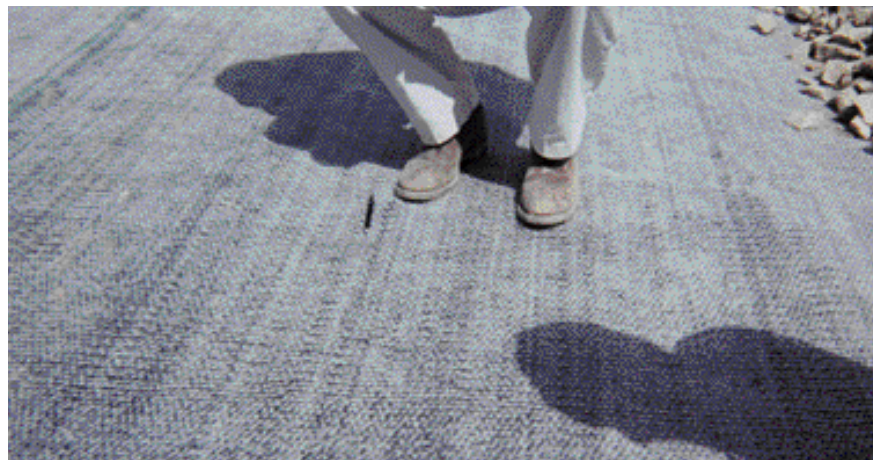
Photo 5: Top of GCL after loading.

The geocomposite remained in good condition and did not reveal signs of tensile strain or other damage from the overlying rock cover. The GCL was intact and in good condition, with only small dimples from the underlying subgrade. The GCL was carefully exhumed and examined to detect any further evidence of bentonite migration or tearing in the geotextile confining layers. Based on the visual examination, the GCL appeared to remain in good condition after being loaded by the scraper, as shown in **Photo 5**.
