PVC aquaculture liners stand the test of time

After three decades of performance, exhumed geomembrane retains strength and flexibility.

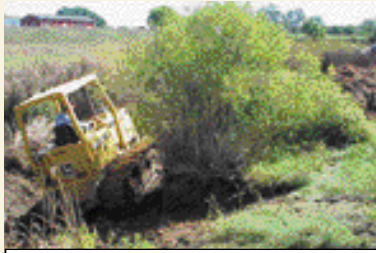
Photo 1. Willow tree and cattails being removed for geomembrane exhumation.

other vegetation (**Photo 1**). These conditions made many types of experiments impossible. Thus, in preparation for new aquaculture experiments, nine of the ponds were cleared and re-lined in September 2000. This provided a unique opportunity to exhume 29-year-old PVC geomembranes and evaluate their engineering properties. It is important to note that none of the ponds leaked or exhibited any problems during the 29 years of service. The nine ponds were re-lined with 20-mil PVC fish-grade geomembrane liner fabricated in circular panels. Each 11,060-ft.² (1,028-m²) panel was made of material supplied by Geon Inc. of Burlington, N.J. The new circular panels were fabricated by Environmental Protection Inc., Mancelona, Mich. Woolf Excavating, Kalamazoo, Mich., installed the one-piece liners in ponds 4 through 8, 10, 16, 17 and 18.

tration and microorganisms on the PVC geomembranes. As mentioned previously, the pond was overgrown with vegetation, which prompted the excavation and pond re-lining. Each of the ponds had a large amount of cattails around the perimeter of the pond (Photo 1) and in the middle of the pond. As the bulldozer removed the soil from the top of the geomembrane under the cattail area, observations were made of the root zone of the cattails. These cattails produced one root stalk about 0.75 in. to 1.25 in. (1.9 cm to 3.17 cm) in diameter, with a mass of smaller roots around the main root. The root length was approximately 1 to 3 ft. (0.3 m to 0.9 m). All roots of the cattails grew down to the PVC geomembrane and then grew horizontally along the top surface of the geomembrane. No evidence of roots penetrating the 20-mil-thick geomembranes was found during field inspection or after holding the geomembrane over a light source.

In one of the ponds a small willow tree was growing about 5 ft. (1.5 m) down-slope of the anchor trench but above the water level. The willow tree was 12 to 15-ft. (3.66 to 4.57-m) tall and had a trunk of 6 to 8 in. (15.2 to 20.3 cm) diameter (Photo 1). As the bulldozer operator cleared the soil from the sides of the tree, it was observed that the large tree roots also grew down to the geomembrane, then turned and traveled along the surface of the geomembrane. The main tree roots were 3 to 5 ft. (0.9 to 1.5 m) long, with some smaller roots extending up to 7 ft. (2.1 m) from the tree trunk. When the dozer pushed the tree over, it slid down the geomembrane to the bottom of the pond, leaving the geomembrane intact. Again no evidence of root penetration was found dur-

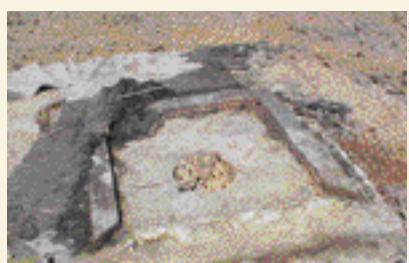
At the center of each pond, an inlet/outlet structure was constructed (**Photo 3**). This structure consisted of a concrete slab, approximately 2.5 ft. x 2.5 ft. (0.76 m x 0.76 m), whose top was level with the liner subgrade. The liner was placed over the concrete, sealed with butyl mastic, and fastened to the concrete using 2-in.-by-4-in. (5-cm-by-10.1-cm) redwood batten strips and concrete nails. This structure and the batten performed well over the nearly 30 years, as indicated by no discoloration of the soil under the PVC geomembrane or around the structure. These observations also indicate that there was little, if any, leakage through the liner in the vicinity of the inlet/outlet structure. In addition, the mastic was soft and flexible after nearly 30 years, which resulted in an effective seal around the nails.

Photo 3. Redwood strips surrounding inlet/outlet structure at bottom of a pond.
