PVC aquaculture liners stand the test of time

After three decades of performance, exhumed geomembrane retains strength and flexibility.

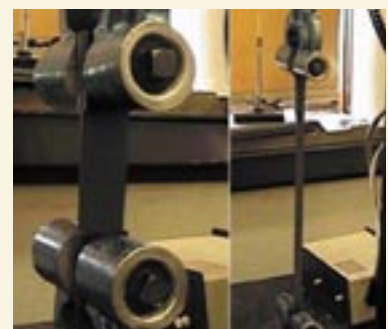
All of the samples removed from the pond were soft and flexible, which is evident from their elongation at break values, presented subsequently, which satisfy specification values. The flexibility of the 29-year-old material also is illustrated by the photographs of a specimen of the sideslope material from below the water line before and during tensile testing (**Photo 2**). It can be seen that the specimen is undergoing substantial elongation during testing. Material removed from the

Photo 2: Exhumed PVC before and during tensile testing.
